Section 4 of this report discusses corridor needs as they relate to the history of crashes, roadway geometric deficiencies, traffic operations issues, bicycle and pedestrian accommodations, rail and utility facilities, and public perceptions.

## 4.01 CRASH HISTORY

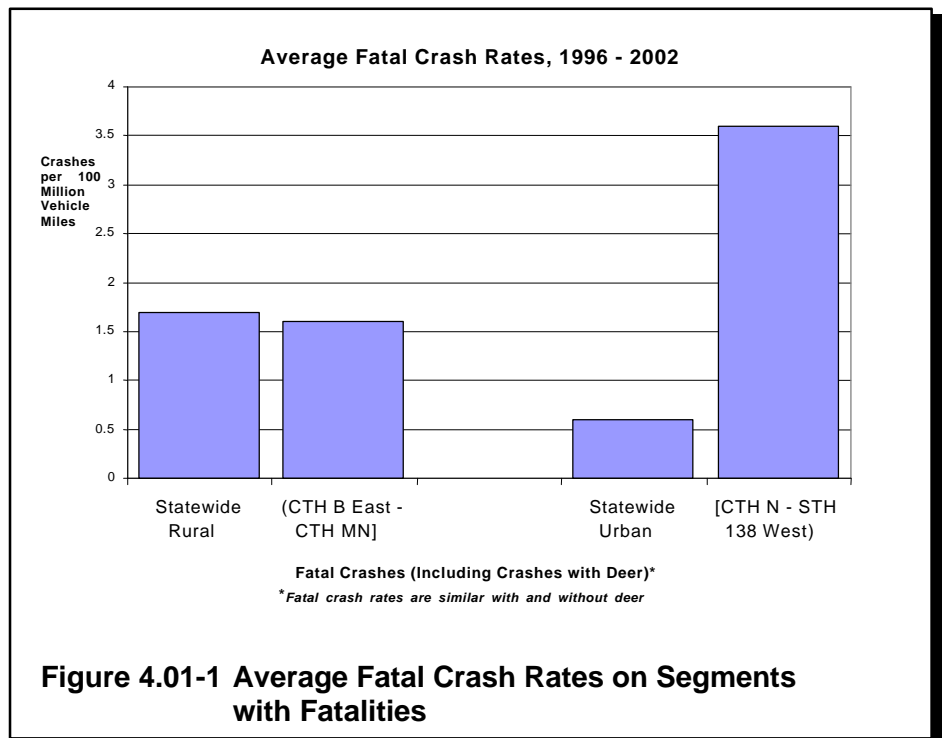
Figure 4.01-1 shows the fatal crash rates for those segments with fatalities. Figure 4.01-2 shows the seven-year average crash rates for rural segments of the corridor. In the figures, an intersection marked with a bracket is included in that segment, while an intersection marked with a parenthesis is excluded.

Crash rates on the predominately rural section of USH 51 between IH 39/90 and Stoughton are below the statewide average for a rural highway.

While corridor crash rates between Stoughton and McFarland are also below the statewide average, the intersection of USH 51 with CTH B (west)/CTH AB has a comparatively high rate. This is discussed in the next section.

In 2002, crash rates on the rural portions of USH 51 were generally equal to or greater than the seven-year average for the segment. Data are insufficient to suggest a general upward or downward trend in the crash rates.

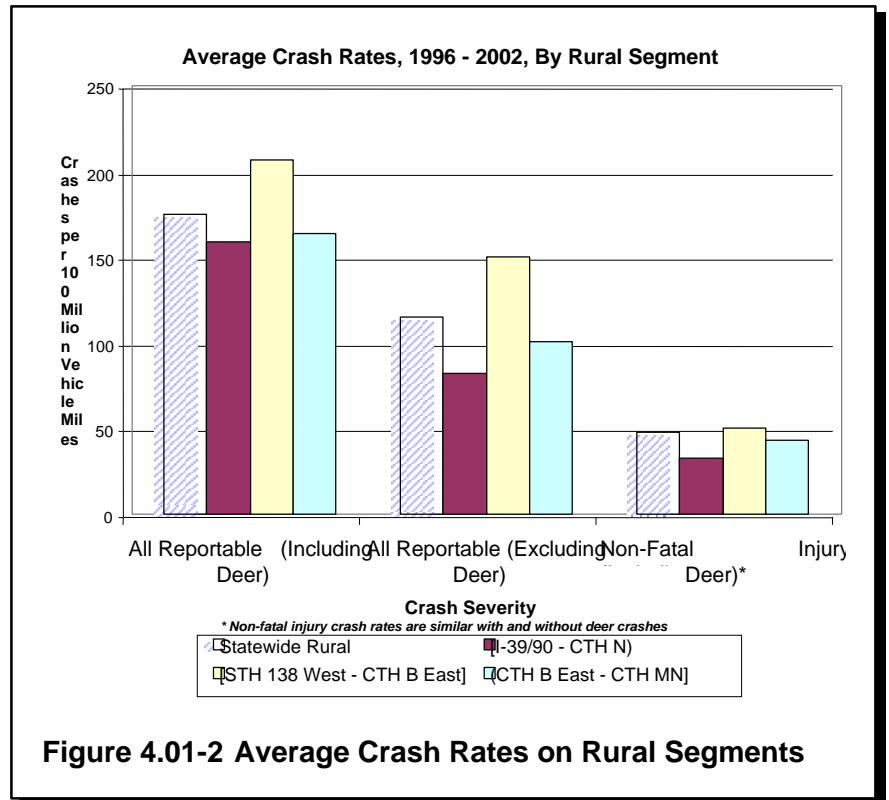
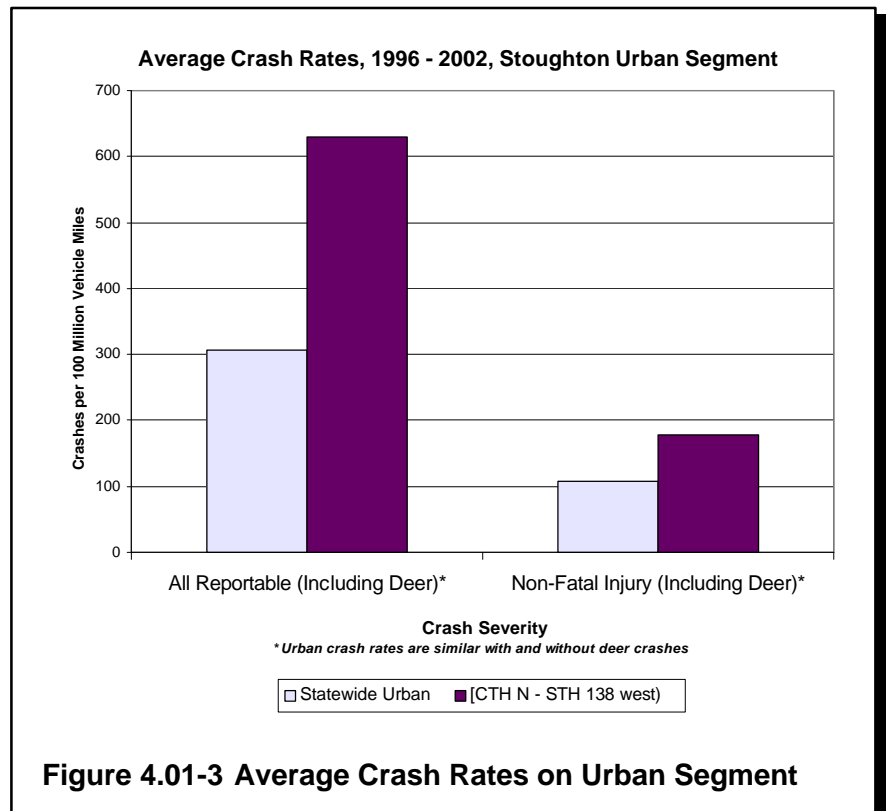
Figure 4.01-3 shows the average crash rates for this urban segment. Figure 4.01-1 shows the fatal crash rates for those segments with fatalities. In the figures, an intersection marked with a bracket is included in that segment while an intersection marked with a parenthesis is excluded.

The crash rate on USH 51 within the City of Stoughton is more than two times the statewide average for an urban highway. The segment's nonfatal injury crash from 1996 through 2002 was nearly twice the statewide average for this period. The fatal crash rate for this period was nearly seven times the statewide average for an urban highway.

With the exception of fatalities, 2002 crash rates on this urban portion of USH 51 were below the seven-year average for the segment. Data are insufficient to suggest a general upward or downward trend in the crash rates.

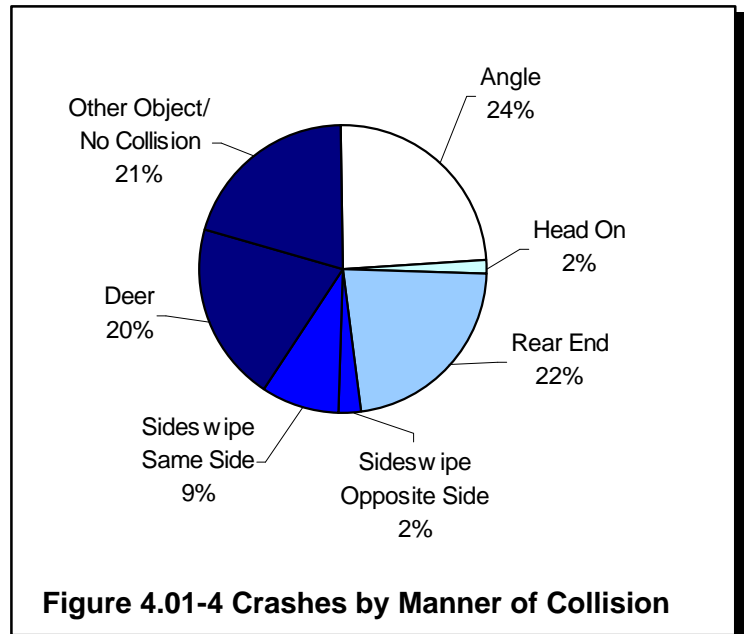
Of the nondeer crashes, angle collisions were the most frequent (accounting for nearly a third of nondeer crashes), followed by rear-ends and collisions with objects. Figure 4.01-4 shows the frequency of each collision type.

Deer were involved in 20 percent of the total reportable crashes from 1996 through 2002. Collisions with deer represent a smaller percentage of the nonfatal injury crashes and none of the fatal crashes.

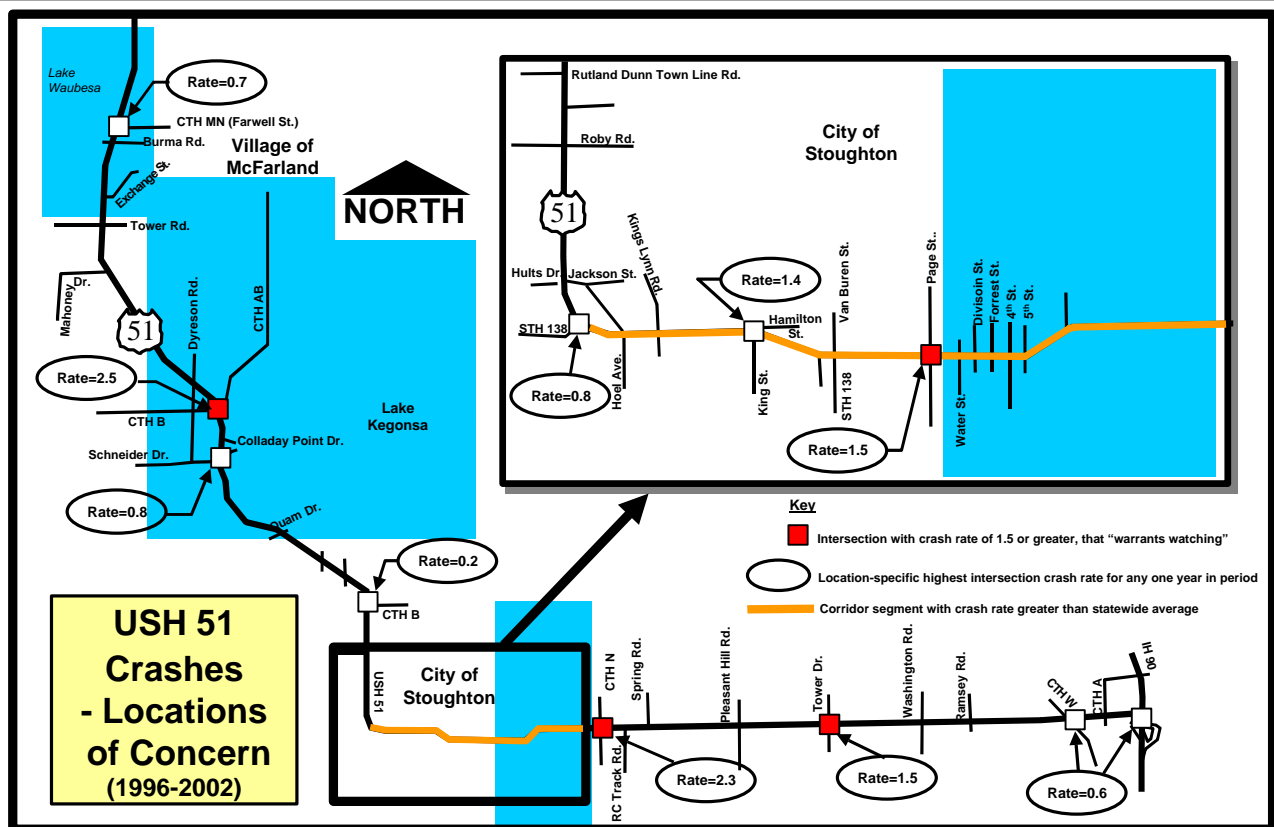
Figure 4.01-5 USH 51 Crashes: Locations of Concern

WisDOT considers an intersection crash rate below 1.5 crashes per one million vehicles entering the intersection (MVE) to be normal, a rate from 1.5 to 2.0 MVE to “warrant watching,” and a rate above 2.0 MVE to “warrant further investigation.” Figure 4.01-5 shows the location and crash rate of several intersections of concern.

With a crash rate of 2.5 MVE, the CTH B (west)/CTH AB intersection experienced 41 reportable crashes over the seven-year study period. This unsignalized intersection “warrants further investigation.” The majority of the collisions were caused by vehicles turning onto USH 51 after failing to yield the right-of-way and by vehicles trying to turn from USH 51 that were rear-ended by other vehicles following too closely. Roadway geometry played a role in most of these crashes: a horizontal curve runs through the intersection and the crest of a vertical curve is located approximately 1000 feet northwest of the intersection.

The CTH N intersection experienced 36 reportable crashes over the seven-year study period. This signalized intersection “warrants further investigation” with a crash rate of 2.3 MVE. Sixty-one percent of the collisions at this intersection were angle crashes. The intersection geometry may confuse drivers unable to discern which movement another vehicle is attempting. CTH N has no exclusive left turn lanes, and USH 51 has neither exclusive left turn lanes nor exclusive right turn lanes.

The intersection with the most crashes was Page Street, with 46 reported crashes over the seven-year study period. Because of the crash rate in 1996, this intersection "warrants watching." There is no evident pattern to the crashes.

In addition to Page Street, Tower Drive (between Stoughton and IH 39/90), 4th Street, and Exchange Street each had single-year crash rates that "warrant watching." Figure 4.01-5 shows the results of the crash statistics analysis schematically.
